# Manhole Inspection Summary

Manhole # S31UU\_016MH

Insp Date: **5/9/07 10:31 AM**

**Location** Address: **348 29TH ST**

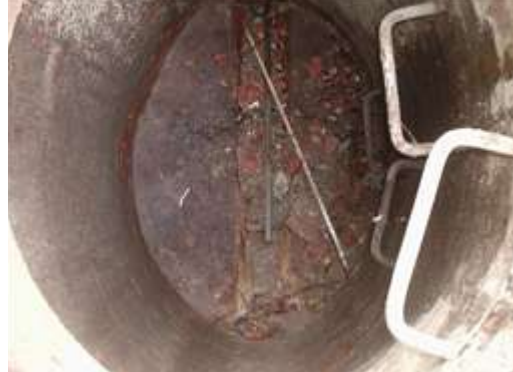
Top View

Evidence of surcharge - Bench debris.

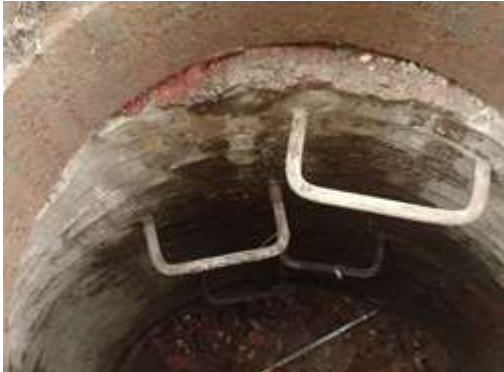
Defect

**Frame** Offset: **1.5** (in.) Condition: ☐ Sound ☐ Cracked ☒ **Leaks**

Condition: ☐ Sound ☐ Cracked ☐ Root Intrusion ☐ Loose Brick ☒ **Deteriorated**

Infiltration: ☐ None ☒ **Joint** ☐ Cracks ☐ Mortar ☐ Roots ☒ **Wall**

Frame leaks. Frame offset. Adjustment deterioration and infiltration. Corbel infiltration.

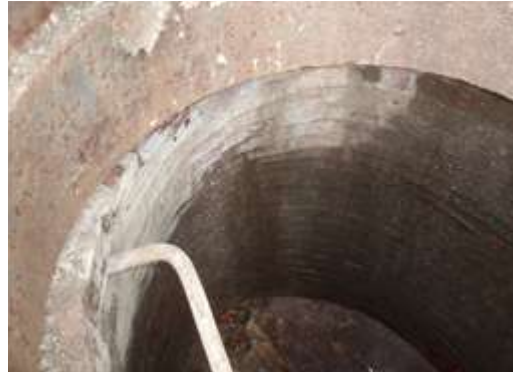
Defect

Frame leaks. Adjustment and Corbel infiltration.

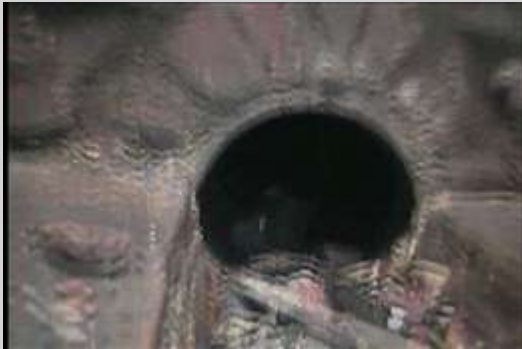
8 in. Circular Gravity Sewer  
Pipe Out @ 12 O'Clock

Rod and Bar (Angled)
